**Warranty Extension: EGR Valve Contamination May Cause Engine Hesitation/Surge or DTC P1491**

(Supersedes 05-019, dated July 20, 2005, to update the information marked by the black bar)

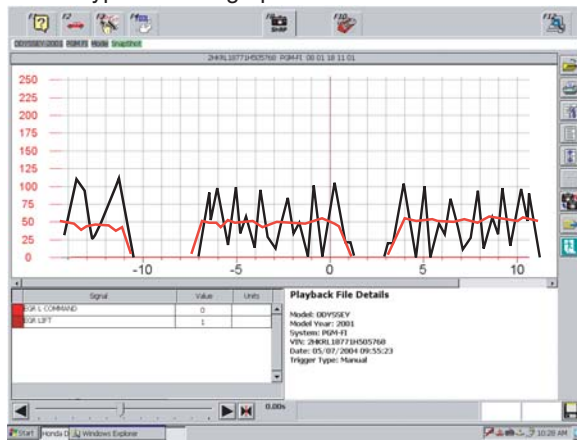
- If the **EGR LIFT** graph is different from the **EGR L COMMAND** graph, the EGR valve is bad. Go to **REPAIR PROCEDURE**.
- If the **EGR LIFT** graph follows the **EGR L COMMAND** graph, the EGR valve is OK. Continue with normal troubleshooting procedures.

This is typical of the graph if the EGR is bad:

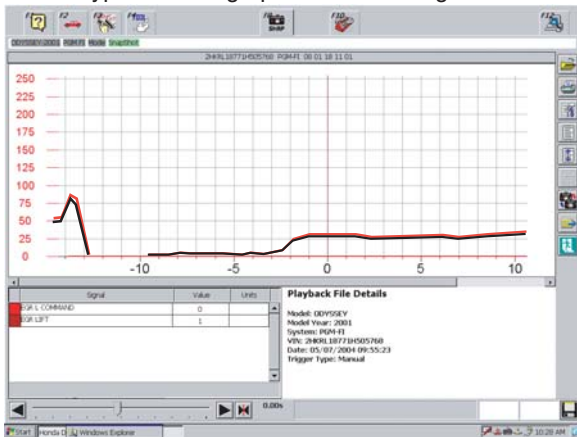
This is typical of the graph if the EGR is good:
