February 4, 2014

BTB 50916 (1402)

Noise From the Front of the Vehicle

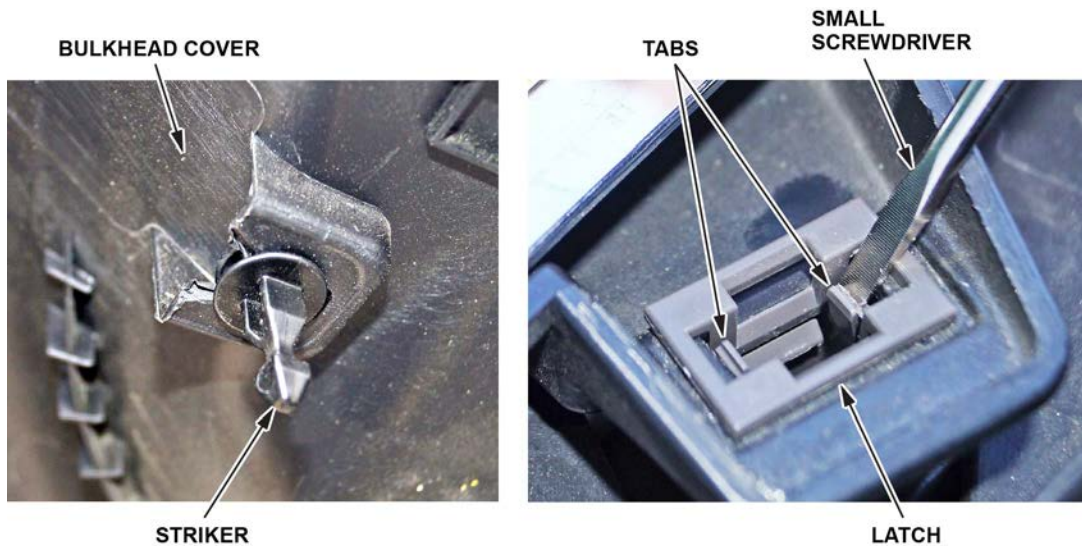
The bulkhead cover fasteners (latches and strikers) may become detached.

2. Remove the 10 strikers from the bulkhead cover, and the 10 latches from the bulkhead and grille. Do not mix the old latches and strikers with the new parts.

NOTE: Use a pocket screwdriver to pry the tabs on the ends of the latches to release them.

3. Install the new latches into the bulkhead and grille, and then install the strikers onto the bulkhead cover.
4. Reinstall the bulkhead cover.
