**Warranty Extension: EGR Valve Contamination May Cause Engine Hesitation/Surge or DTC P1491**

(Supersedes 05-019, dated July 20, 2005, to update the information marked by the black bar)

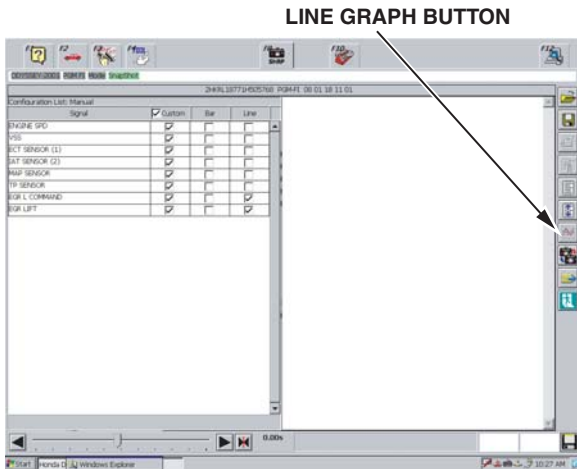
- If the **EGR LIFT** graph is different from the **EGR L COMMAND** graph, the EGR valve is bad. Go to **REPAIR PROCEDURE**.
- If the **EGR LIFT** graph follows the **EGR L COMMAND** graph, the EGR valve is OK. Continue with normal troubleshooting procedures.
